List of Classified Structures

Bates Well Ranch Windmill No. 2

Structure Number: HS01N

Park: Organ Pipe Cactus National Monument

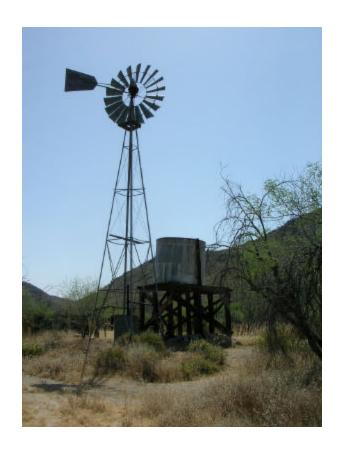
Metal A frame tower w/ windmill. Adjacent cylindrical tank atop stilted Short Physical Description:

platform built of RR ties. Located near eastern corral.

Long Physical Description: Windmill #2 is located just west of the Eastern Corral. The steel tower of the

> windmill is intact and in place along with the wind wheel, its sails, and the vane. Stenciled on the vane is the name "MOMSEN-DUNNEGAN-RYAN Co. EL PASO TEXAS." The adjacent water tank is galvanized metal and sits on a raised wooden platform. It is 6' 6" in diameter and 6' high. The platform

is 8' 6" wide and 7' tall for an overall height of 13' for the water tank
